Operational Environmental Management Plan (OEMP)

238-258 Captain Cook Drive, Kurnell NSW

Prepared for Dicker Data Limited

Report No: 19074RP04

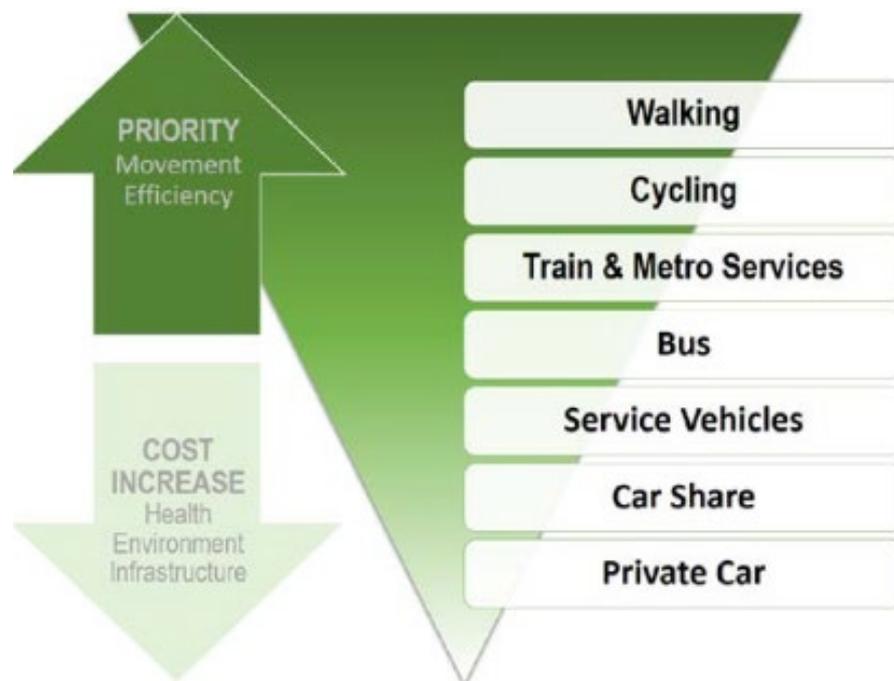
Figure 1: Movement Hierarchy

Having regard for the above, this WTP would seek to adopt the movement hierarchy shown in **Figure 1** with priority given to ‘active transport’.

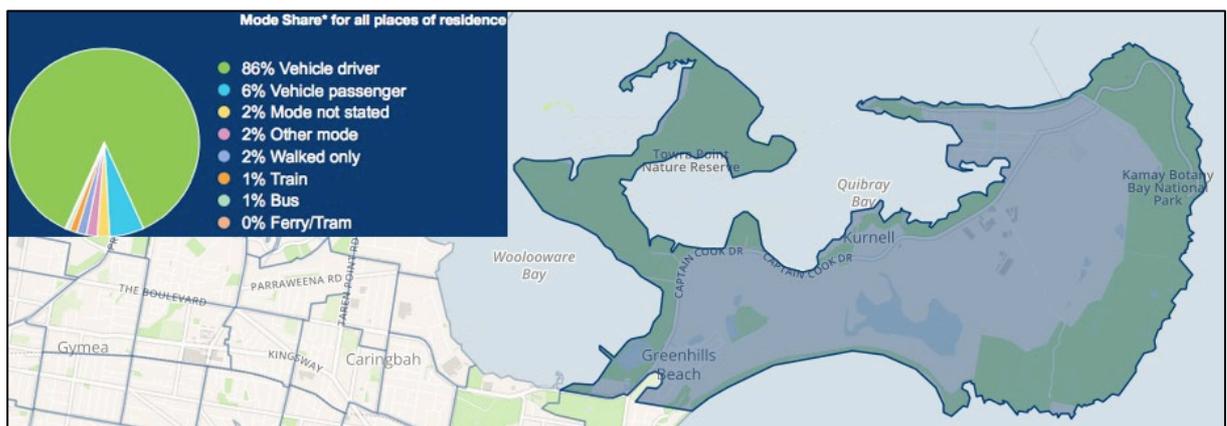
Figure 2: Journey to Work Mode Share - 2011

The modal share data shows that a majority of the commuter trips are undertaken as a vehicle driver (86%) with approximately 6% of commuter trips undertaken by as a vehicle passenger.

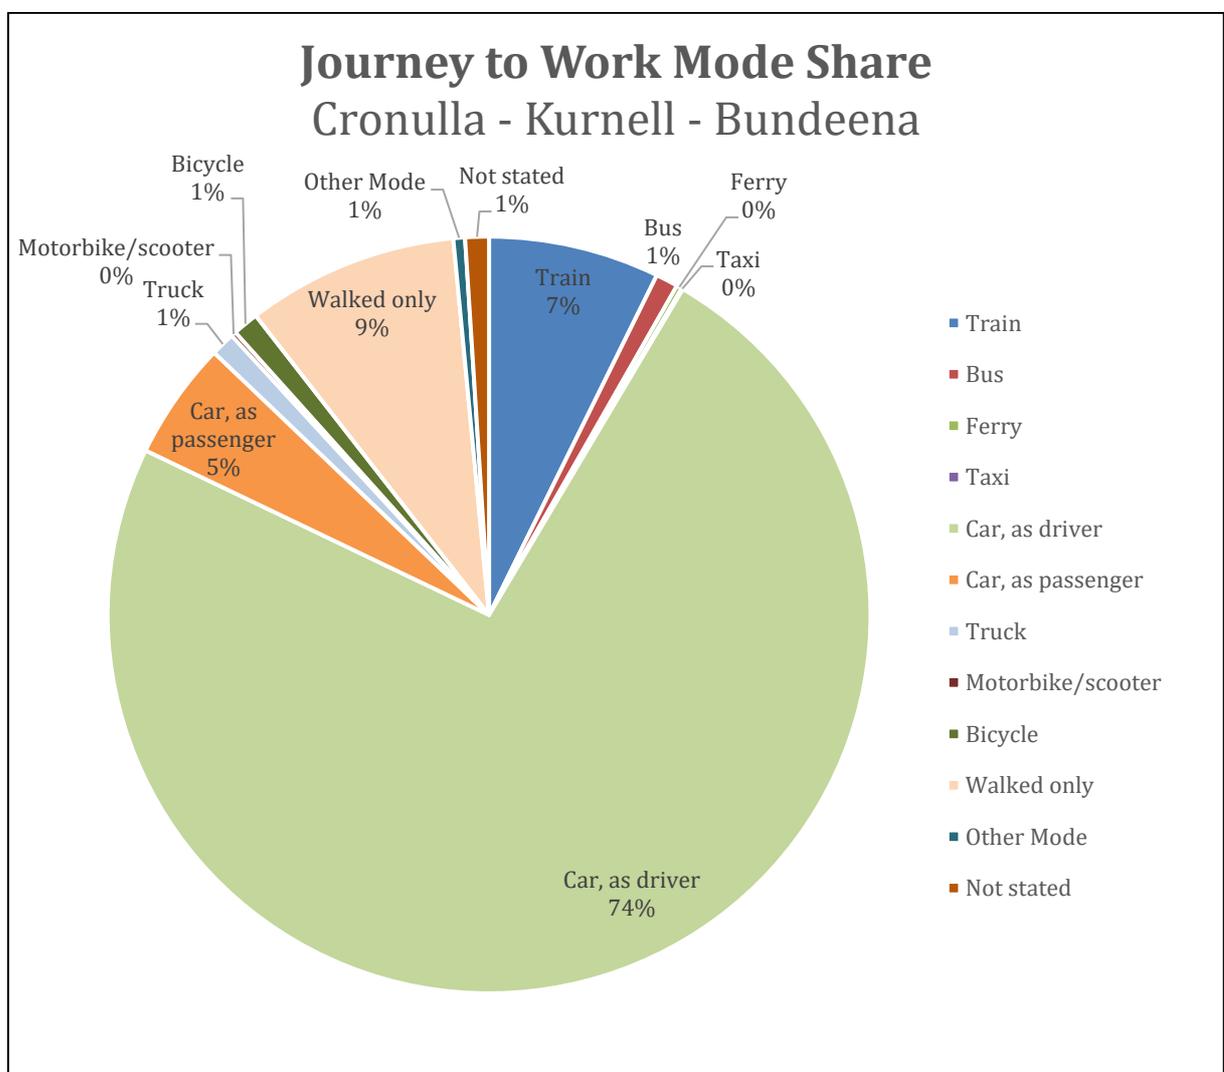
Figure 3: Journey to Work Mode Share - 2016

Further analysis has been undertaken for the 2016 Census data, which now provides statistical data for a larger area consisting the suburbs of Cronulla, Kurnell and Bundeena. This area is referred to as a Statistical Area Level 2 (SA2), which is purposed to represent a community that interacts together socially and economically. The SA2 code for Cronulla, Kurnell and Bundeena is 128011604 and the data analysis results are presented as a pie chart in **Figure 3** below.

It is apparent that private car usage is still relied upon as a primary mode of transport. Comparatively, private car usage is lower in the 2016 data. This is likely attributed to the larger statistical area which

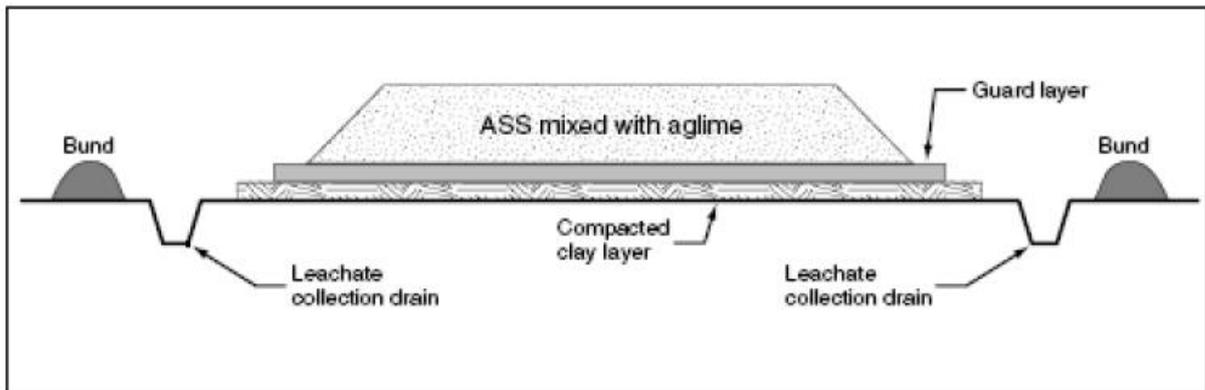
Figure 1: Schematic cross-section of a treatment pad, including clay layer, guard layer, leachate collection system and containment with bunding¹

Figure 1, below, shows a cross section of a typical treatment pad.

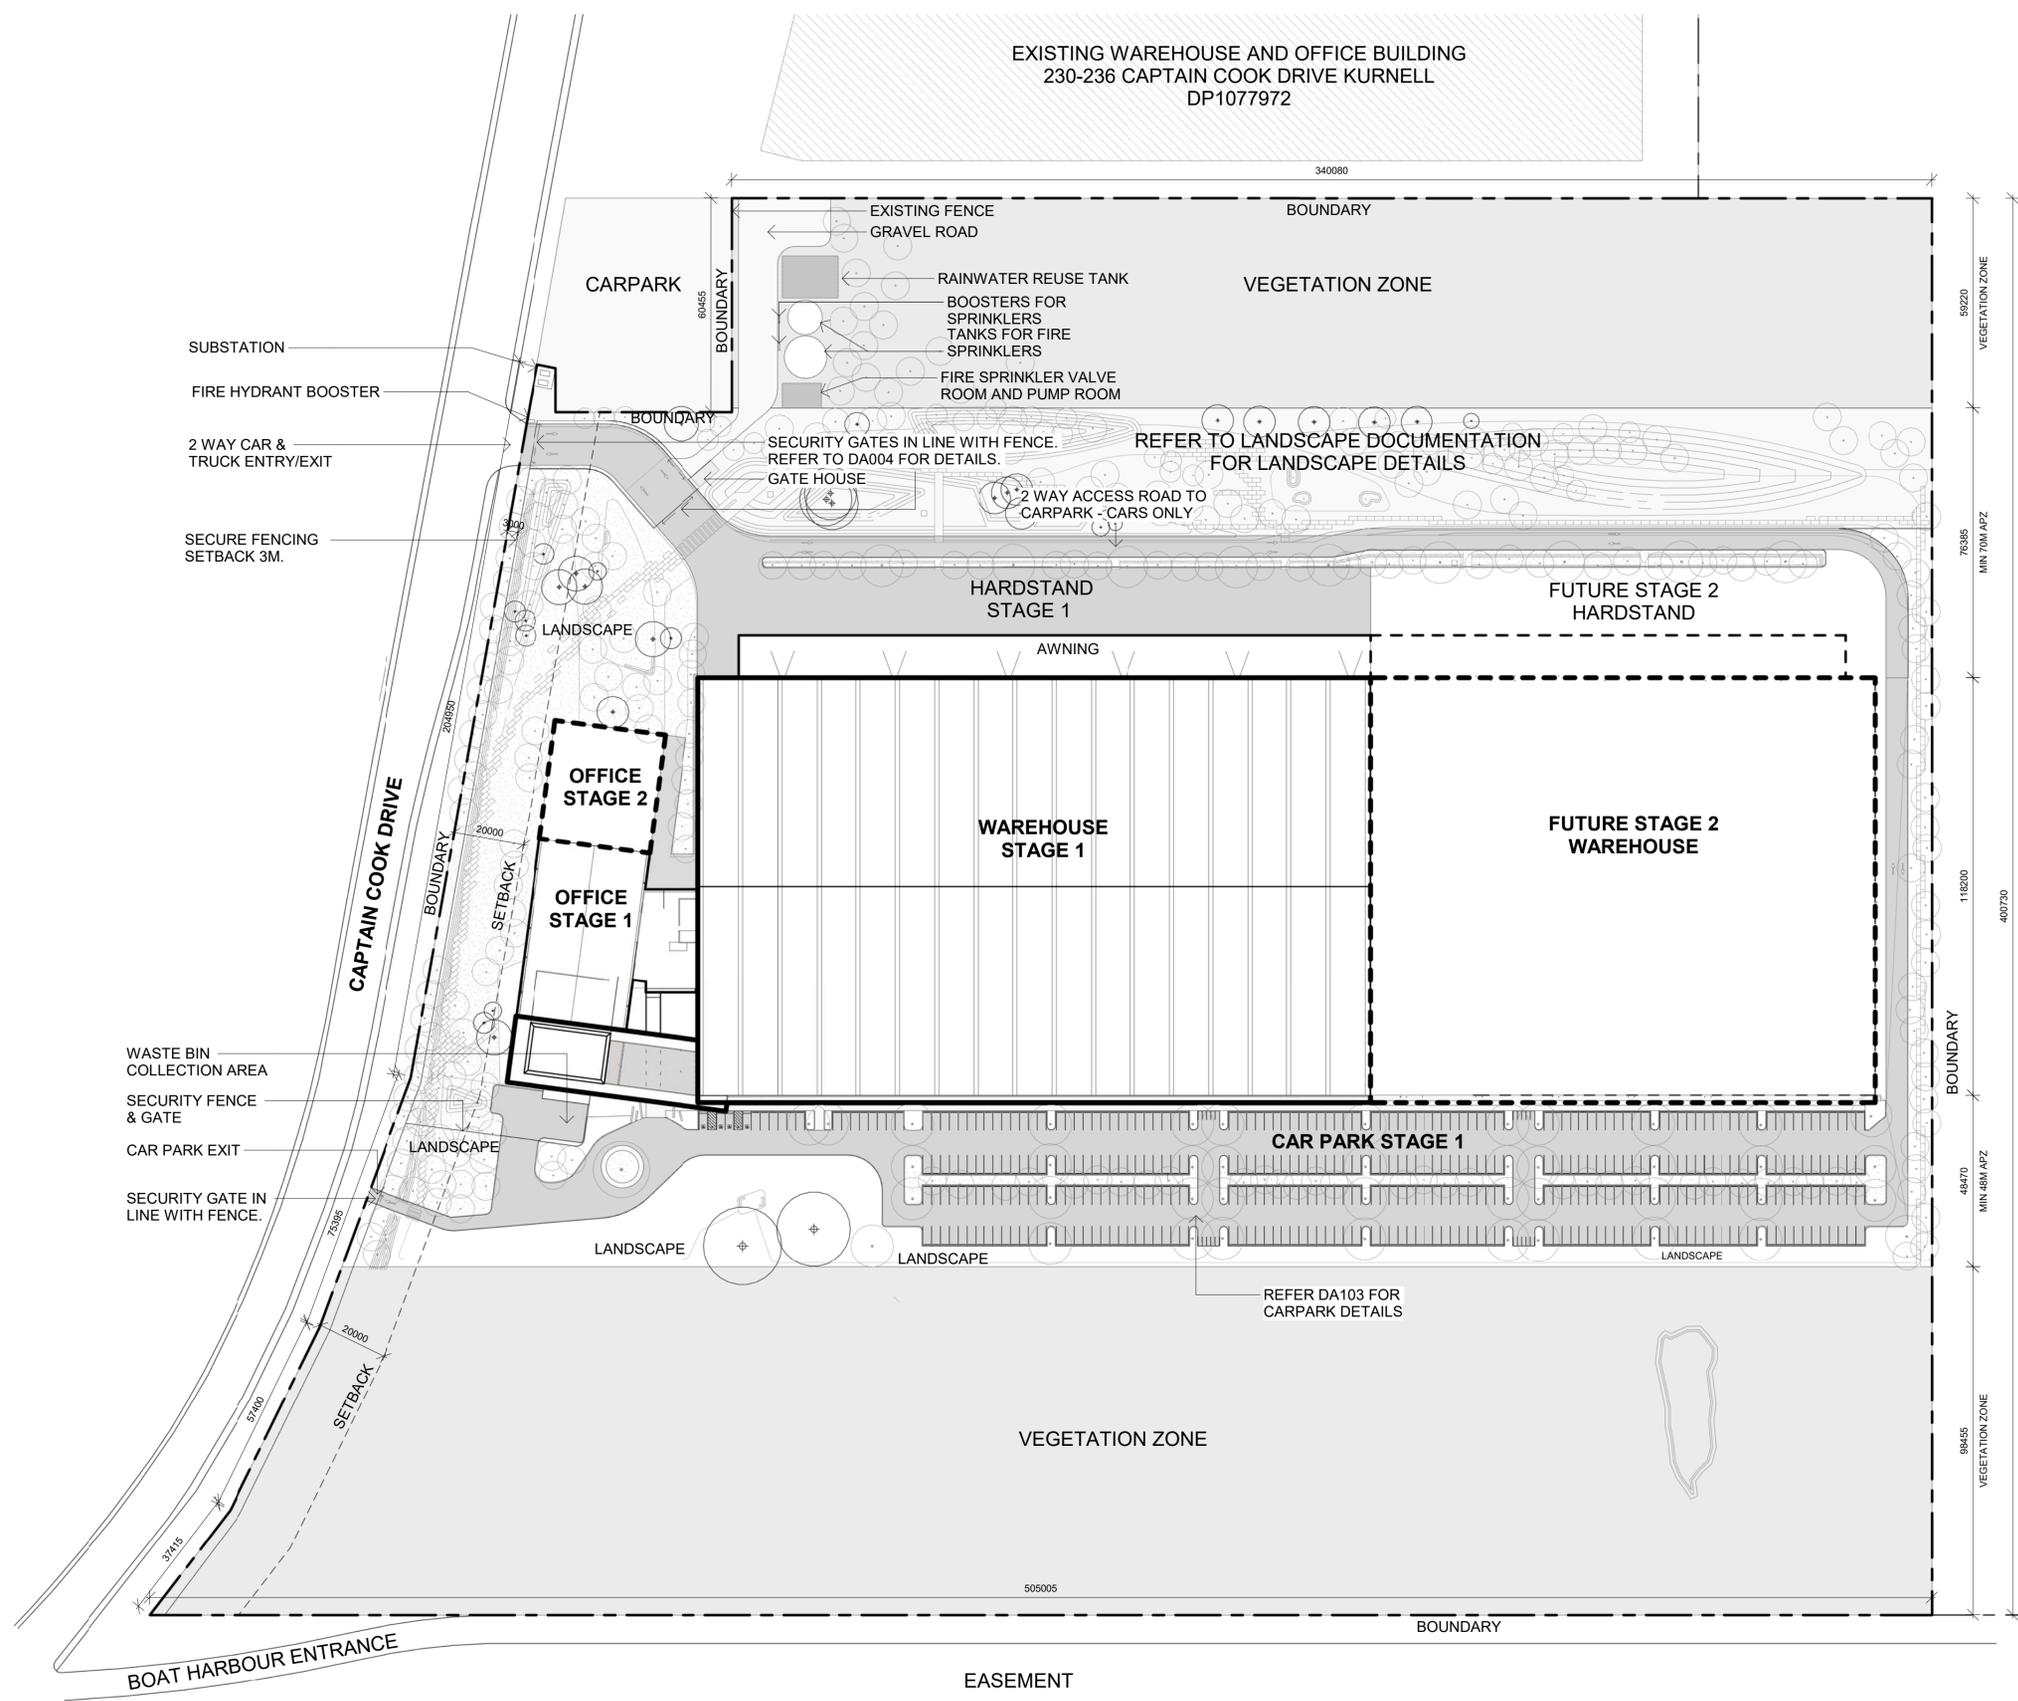
1 SITE PLAN - STAGE 1
SCALE 1 : 1000

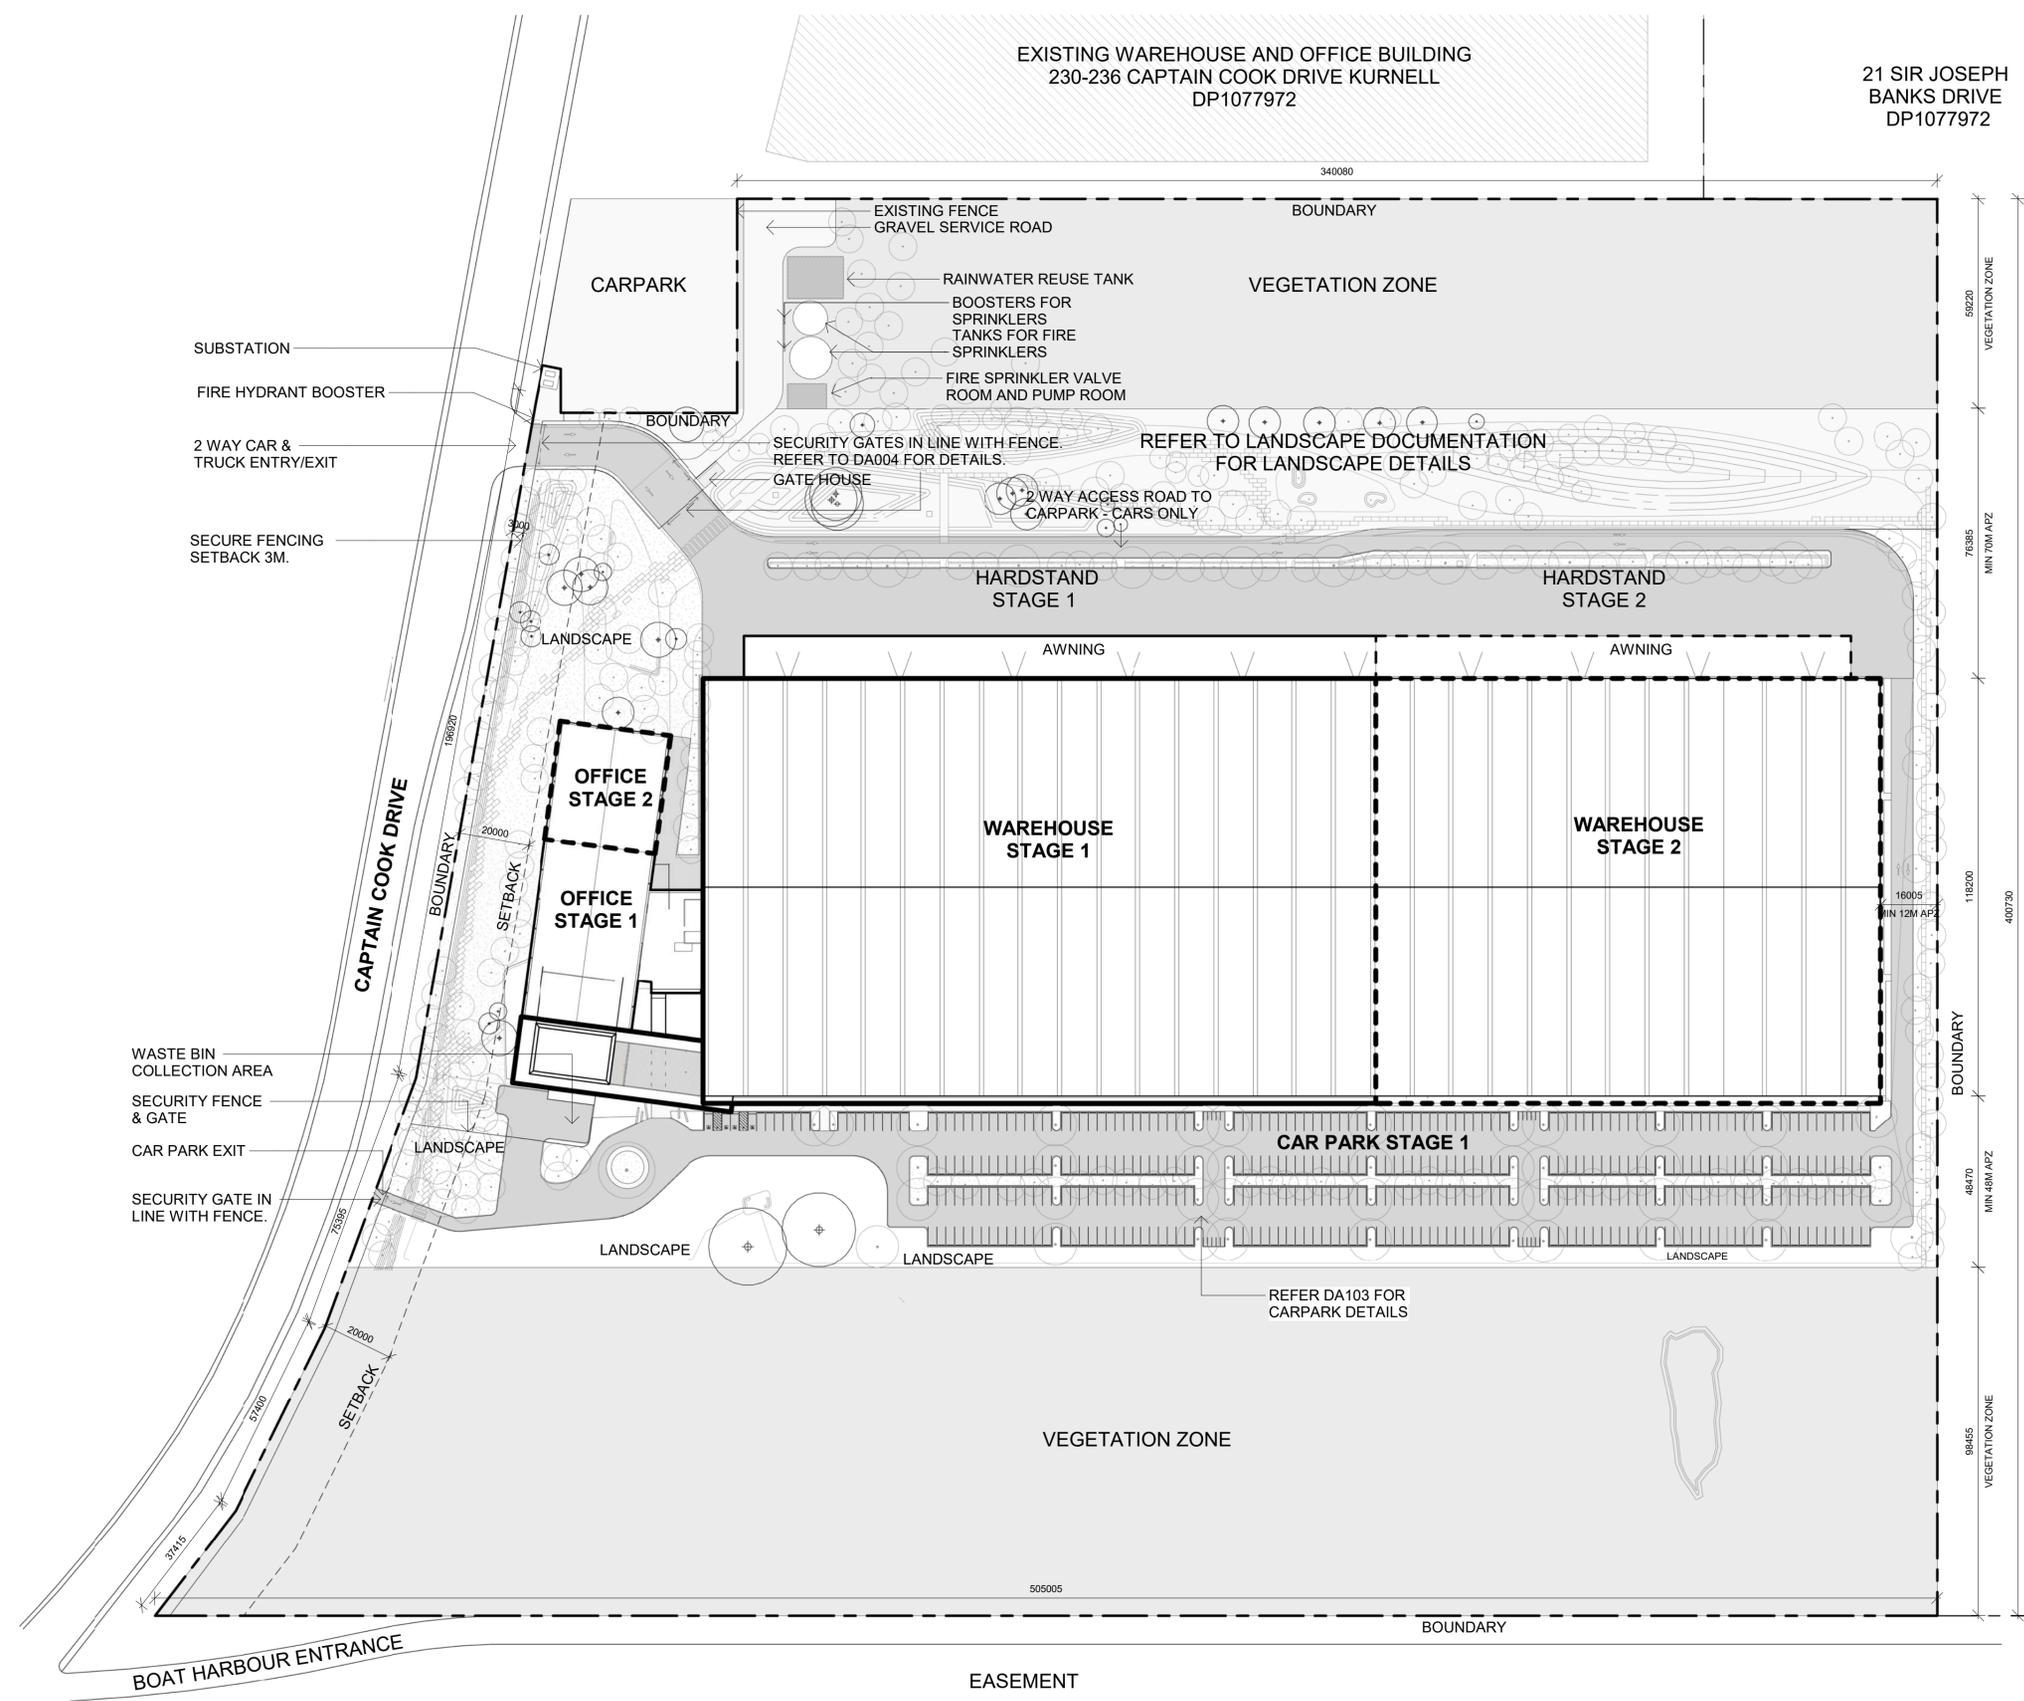
1 **SITE PLAN - STAGE 2**
SCALE 1 : 1000
